Measuring Fluctuating Pressure Levels and Vibration Response in a Jet Plume

Douglas J. Osterholt
Douglas M. Knox
ATA Engineering, Inc., San Diego, California

ABSTRACT

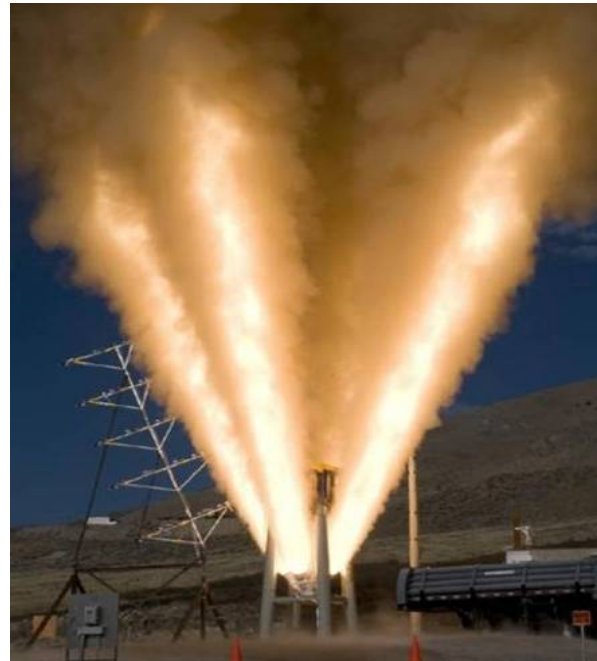
Figure 1. Abort motor plume position relative to the Orion CM and LAS (left) and photo of plumes during ST-1 static test firing (right).

In analysis-based predictions, the abort motor's plume-induced fluctuating pressure levels occurring during LAS abort separation are expected to exceed 175 dB, resulting in internal crew module component damage. The LAS crew module position relative to the plume from the LAS abort motor is shown in Figure 1 on the left; the figure on the right shows a previous test firing of the LAS abort motor. A large unknown in the analysis is the efficiency of the plume loads to drive vibration and vibroacoustic transmission of a structure. This test provided the opportunity to obtain test data characterizing the fluctuating pressures in the jet plume and the induced vibration of a steel panel. Further, this insight into the environment could be used to validate analytical methods to predict this behavior. The instrumentation panel was designed to measure fluctuating pressures both upstream and downstream of a vibration panel. The panel consisted of a 1/8"-thick steel plate on which accelerometers were mounted to measure the response due to the fluctuating pressures. The goal after the test was to show that analytical methods can be used to

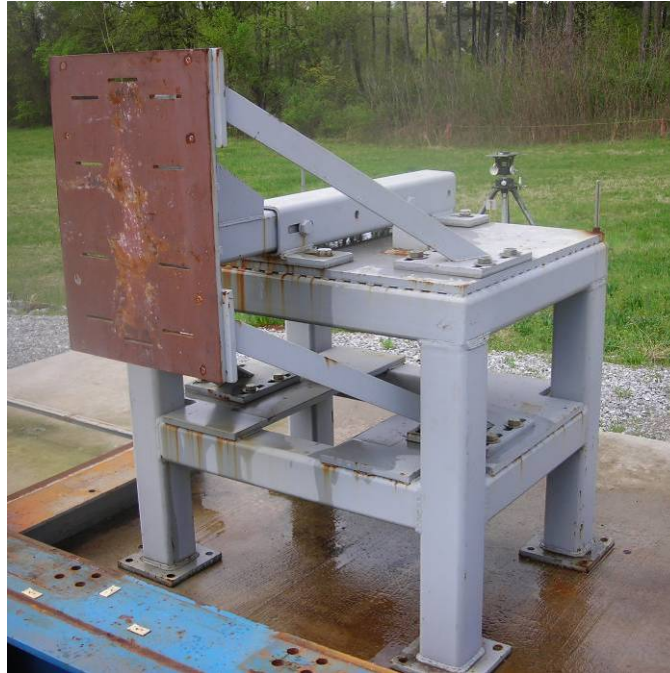
Figure 5. Support table available from MSFC – bolted to the concrete pad.

The design of the instrumentation panel was configured to be integrated with a support table, which was available from a previous test at MSFC. A photo of the support table that was previously used is shown in Figure 5. This provided a robust support and interface to hold the instrumentation.

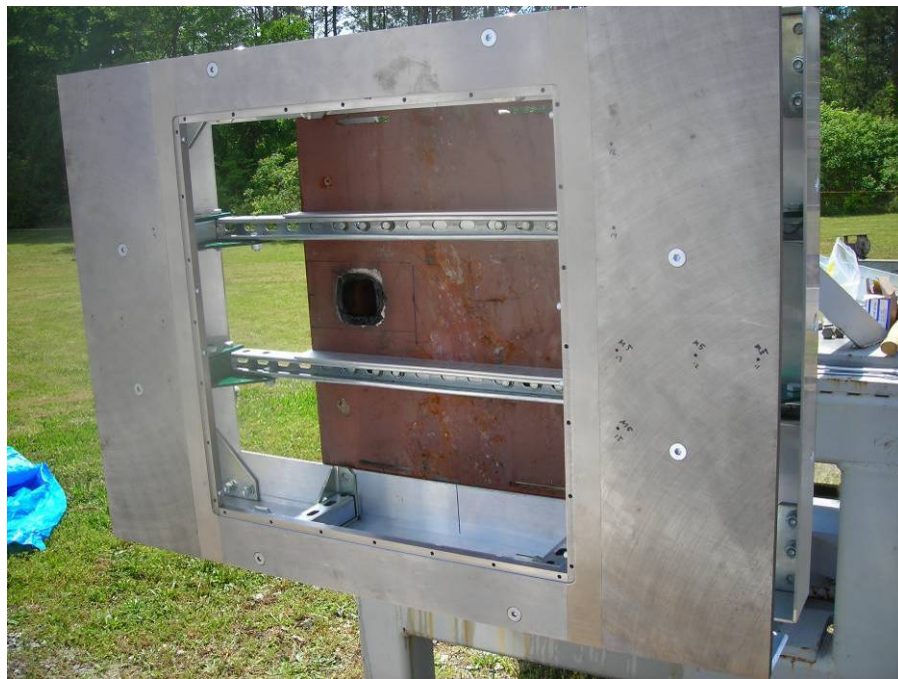
Figure 7. Steel unistrut supports bolting the instrumentation panel to the support table.

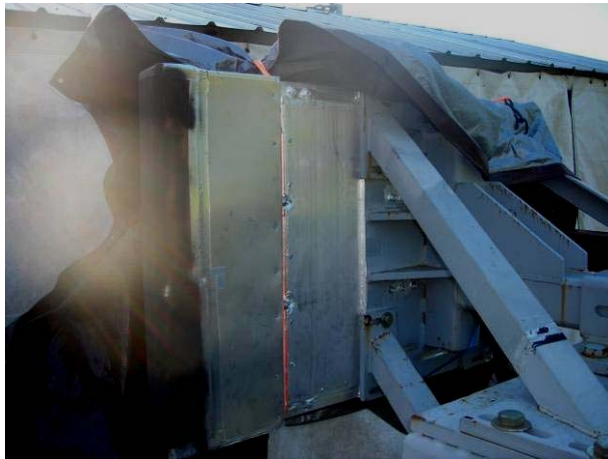
Figure 8. Close-out panel on back side of box.

would wrap around the panel and damage instrumentation cables on the back side. This could also affect the response by measuring the unwanted wrap-around pressures that could affect the response. To minimize this risk, close-out panels were added to prevent back pressure from wrapping around and influencing the measurements and to protect the instrumentation, as shown in Figure 8. We also installed a pressure transducer inside the box to characterize the amount of pressure leaking into the box. Acoustic damping internal to the box was also added to reduce reflected sound waves inside the box. The last concern was the heat from the plume melting the thin wall airfoil and the aluminum close-out panels on the top and bottom. To minimize this risk, thin sheets of self-adhesive cork were applied to the air foil and the top and bottom panels to protect the thin metal from the heat of the jet plume (Figure 9 and Figure 10). High-temperature tape was also used to seal the box frame. This helped prevent hot gases from entering the box and damaging cables.

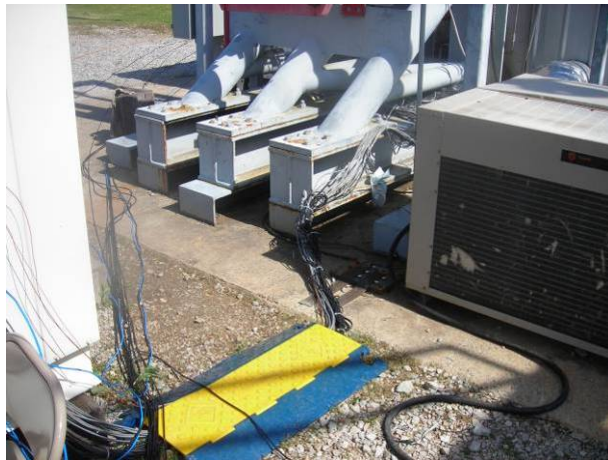
Figure 14. Cable routing along the ground.

All cables were routed under the steel grid next to the motor and then up through a window into the data acquisition room, as shown in Figure 14 and Figure 15.
